The Leaky Lake House: Driving Rain Penetration & the Importance of a Proper Rain Screen

By Kim Pressnail, Associate Professor of Civil and Mineral Engineering, University of Toronto & Andrea Atkins, Adjunct Professor in Architecture, University of Waterloo

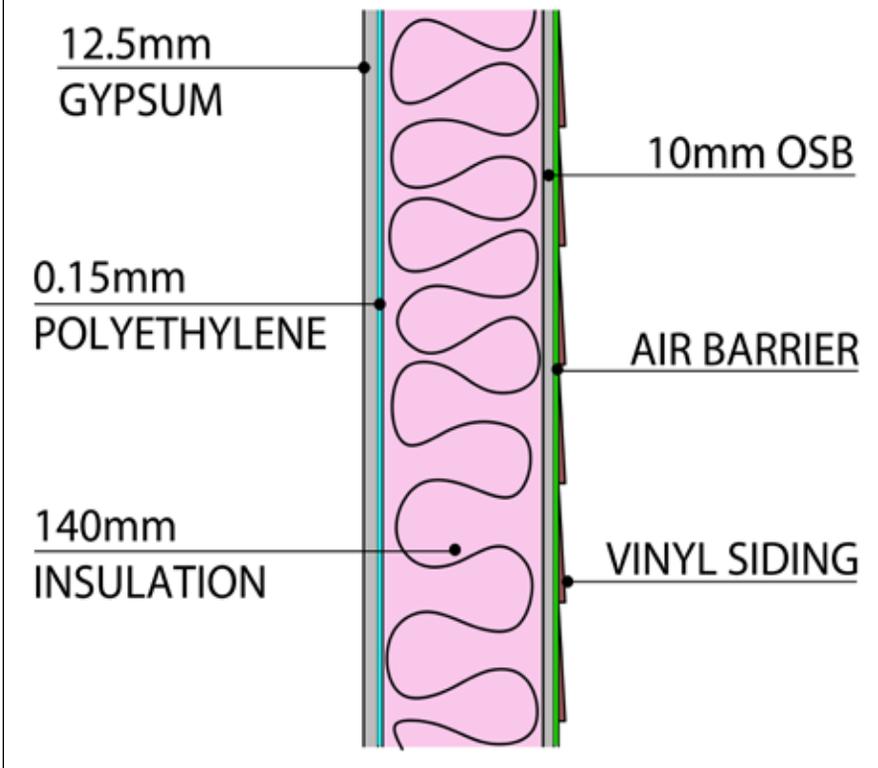
EXISTING VINYL ASSEMBLY

The profile of the “repaired” wall assembly suffering rain penetration.

In a desperate attempt to keep the rain out of the wall, a contractor had removed the original vapour-permeable air retarding membrane and replaced it with a peel and stick membrane, a product intended for use as an ice and water shield on sloped roofs.

Sadly, the retrofitted wall was destined for failure in two possible ways: by concealed condensation due to vapour diffusion from the inside; or by driving rain penetration. Why? First, the peel-n-stick membrane was almost impermeable, and

it was on the cold side of the thermal control layer in a home located in ASHRAE Climate Zone 6. Even a crude hygrothermal analysis using hand calculations will show that the retrofitted wall will eventually fail through concealed condensation. However, since vapour diffusion is an extremely slow process, the wall had not yet

However, the wall did fail because of rain penetration. Although the peel-n-stick membrane was intended to keep water out, in fact, because of the way in which it was applied, it still let water in but didn't allow it to drain back out as easily as

it had before. Rain penetration occurred because of air leakage and the lack of a pressure-moderated rain screen. Although the peel-n-stick membrane was an air barrier, it was not made continuous with any of the wall penetrations, including windows, sliding glass patio doors, and even electrical penetrations.

As we described in our first article a couple of years ago, to address the rain penetration issues, the vinyl siding and the peel-n-stick membrane were removed. The impermeable membrane was replaced with a vapour-permeable air barrier, and critical areas around windows and doors were air- and weather-sealed using various

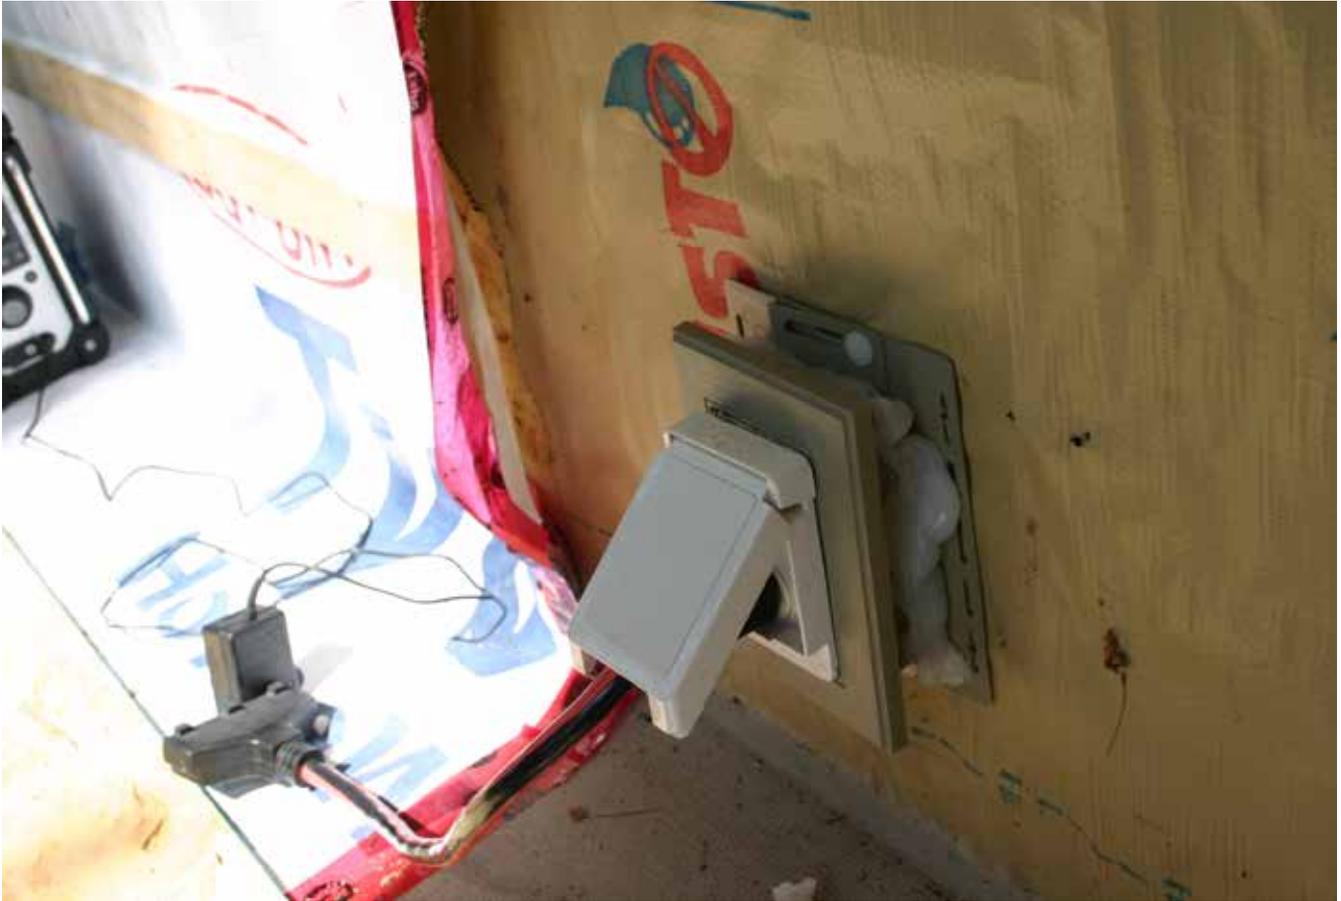
A failed attempt to air-seal an electrical outlet.

Although attempts were made to make the membrane continuous, most of the attempts failed. The photo on page 23 shows an example of the gobs of silicone sealant that were applied in vain to an electrical outlet that penetrated the membrane. As built, even a small hole in the sealant would still be a path for air pressure-driven films of water. Without the provision of a vented cavity and a proper rain screen, such a brute force caulking approach was doomed to fail, and it did.

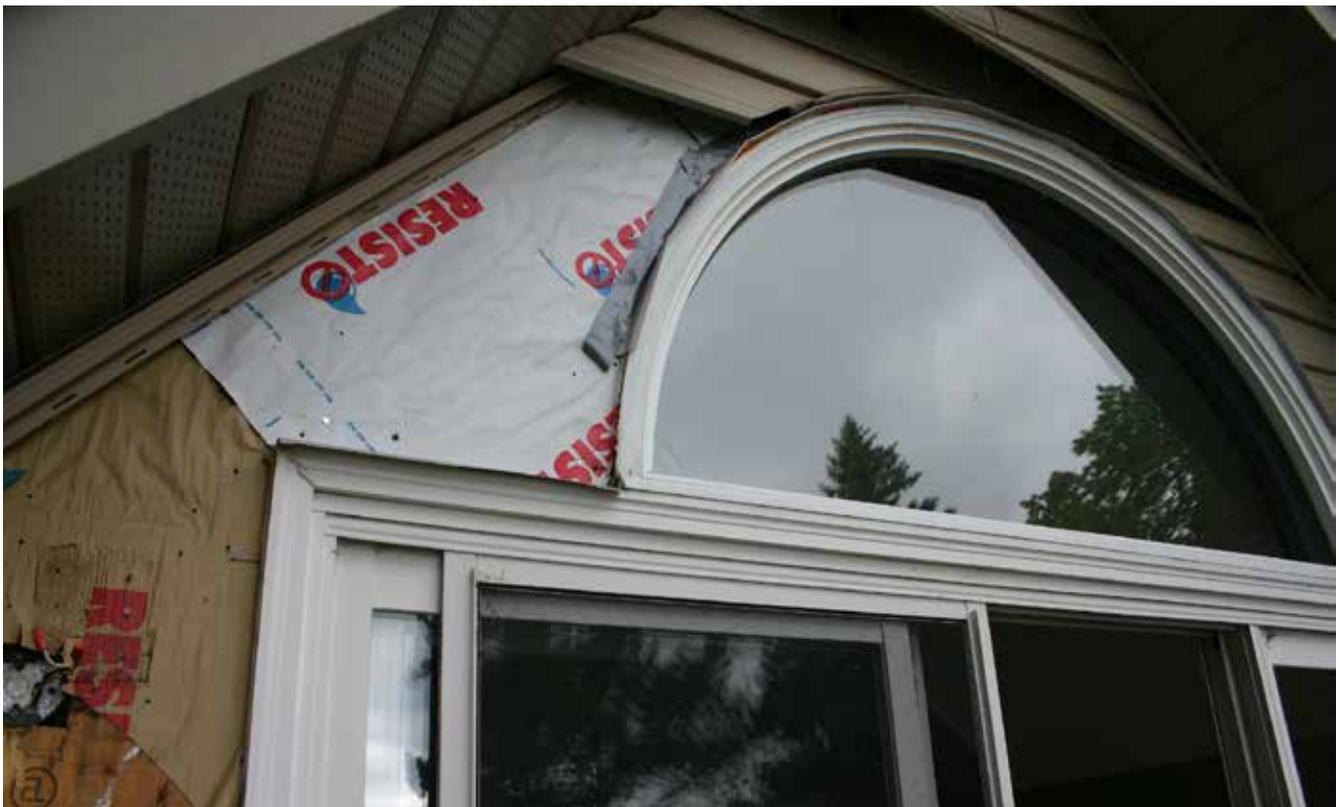
In the photo on this page, you can see another poor detail for managing rain-water. Someone had attempted to direct water from the peel-n-stick membrane and onto the flashing surrounding a shaped window using duct tape, not flashing tape. After a few years in service, the duct tape had become dust tape. Further, following the removal of the shaped window, it was found that there was no air seal between the window frame and the air barrier.

Matters were made worse when no framing or header support for the shaped window were provided. This meant that the window flanges were merely nailed to the adjacent unsupported OSB sheathing and left unsealed. Since the OSB was largely unsupported, the window could

deflect up to a centimetre or two in high winds, thereby causing the face-seal caulking to fail. Not surprisingly, water entered around the window despite the gobs of repair caulking, and the wood framing decayed.

An unsupported and unsealed shaped window.

flashing tape products. Further, proper metal head flashings with end dams were installed.

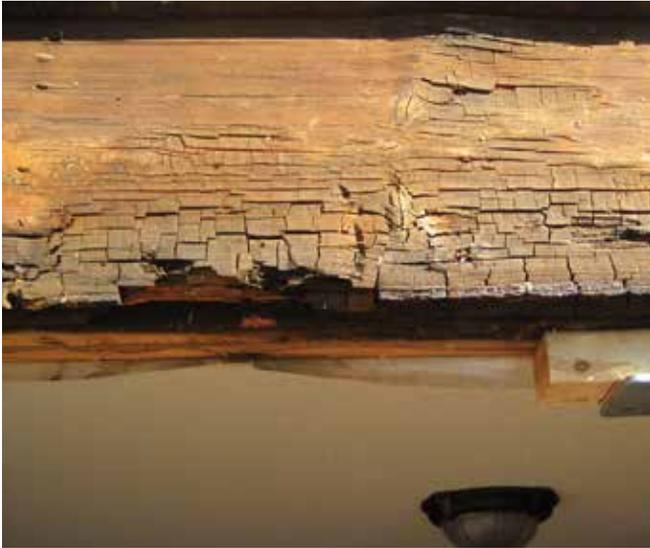
Further, water running down from the shaped window penetrated the second-floor patio doors below and wet the supporting sill which formed the header of the first-floor patio door. The built-up header, spanning 2.7 metres and comprised of three nominal 2x10 spruce members, had decayed as well. As you can see in the photo on the top-left of the next page, the header is rotten. The outermost member lost all of its capacity and the middle member likely lost about 50 percent of its capacity. The innermost member, which had been kept dry by heat losses from the house, was only slightly decayed.

The rotten header above a three-panel patio door:

The rotted and leaking sliding glass doors were replaced with new insulating glass units, which were designed and constructed specifically for driving rain exposure. The sliding glass panels of the new doors are on the outboard face of the fixed unit, and so when the wind blows, the same wind pressure that drives water inward, also pushes the sliding door more tightly against the seal: the higher the wind pressure, the better the seal. This is a great patio door design for resisting rain penetration, but it's not perfect. In the winter, the exterior track must be kept clear of ice and snow in order to keep the track from icing.

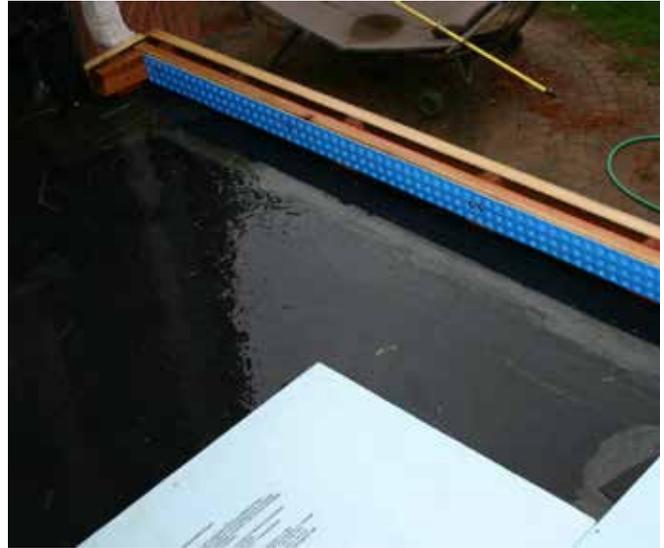
Insulating the protected membrane roof.

After constructing a proper rain screen, there was one more source of rain penetration that needed to be addressed. The original low-slope roof/deck adjoining the first floor and covering a portion of the walkout basement below was only

25 millimetres lower than the sill of the sliding patio doors. The roof was low-slope and wind could easily drive rain under the door and into the house. The existing roof/deck was covered with an exposed vinyl membrane, and the surface of the membrane was about 150 millimetres higher than the interior floor. Such a construction detail was just waiting to fail.

To address the roof/deck issues, the roof was first lowered about 300 millimetres, and a protected membrane roof was installed. An EPDM fully-adhered membrane was applied to 19-millimetre tongue-and-groove plywood that was supported by nominal 2x10 spruce joists. The membrane was integrated with the air barrier on the wall and became a part of

the air, water, and vapour control system. Then, 100 millimetres of extruded polystyrene insulation was placed outboard of the roof membrane, while 100 millimetres of

glass fibre insulation was used to thermally insulate the joist space. Since the EPDM membrane served as the vapour control layer as well, no polyethylene sheeting was

applied on the interior. Instead, the ceiling joists were covered with 12.5-millimetre gypsum board that was painted with two coats of vapour-permeable latex paint.

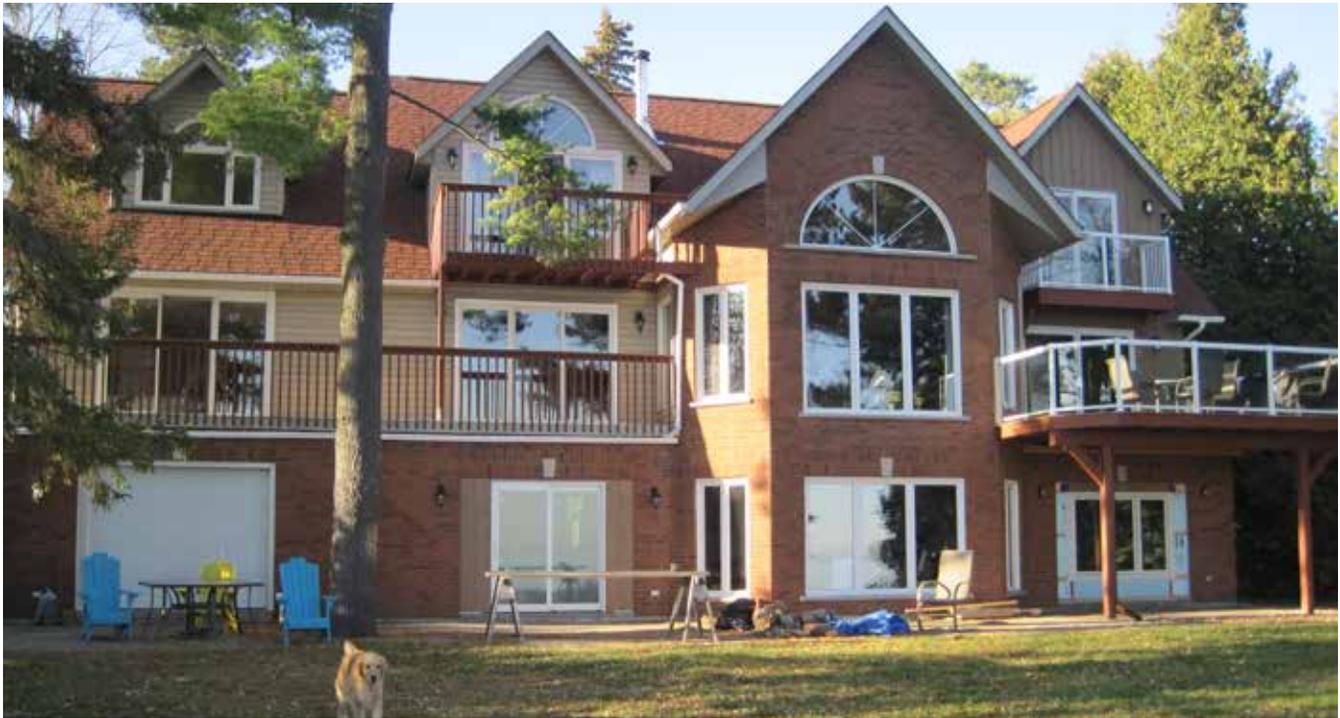
The board and batten siding has been partially completed.

Having created a continuous air barrier, the next step in creating an effective rain screen was to add 25-millimetre pine board and batten siding. The siding was installed over 19-millimetre strapping, which was used to create an airspace. The board and batten siding was open to the air at the top and the bottom of the air space. As well, since the boards were rough sawn, a small air gap existed between the battens and the boards. Accordingly, the

air space behind the board and batten siding was well-vented and, therefore, pressure-moderated.

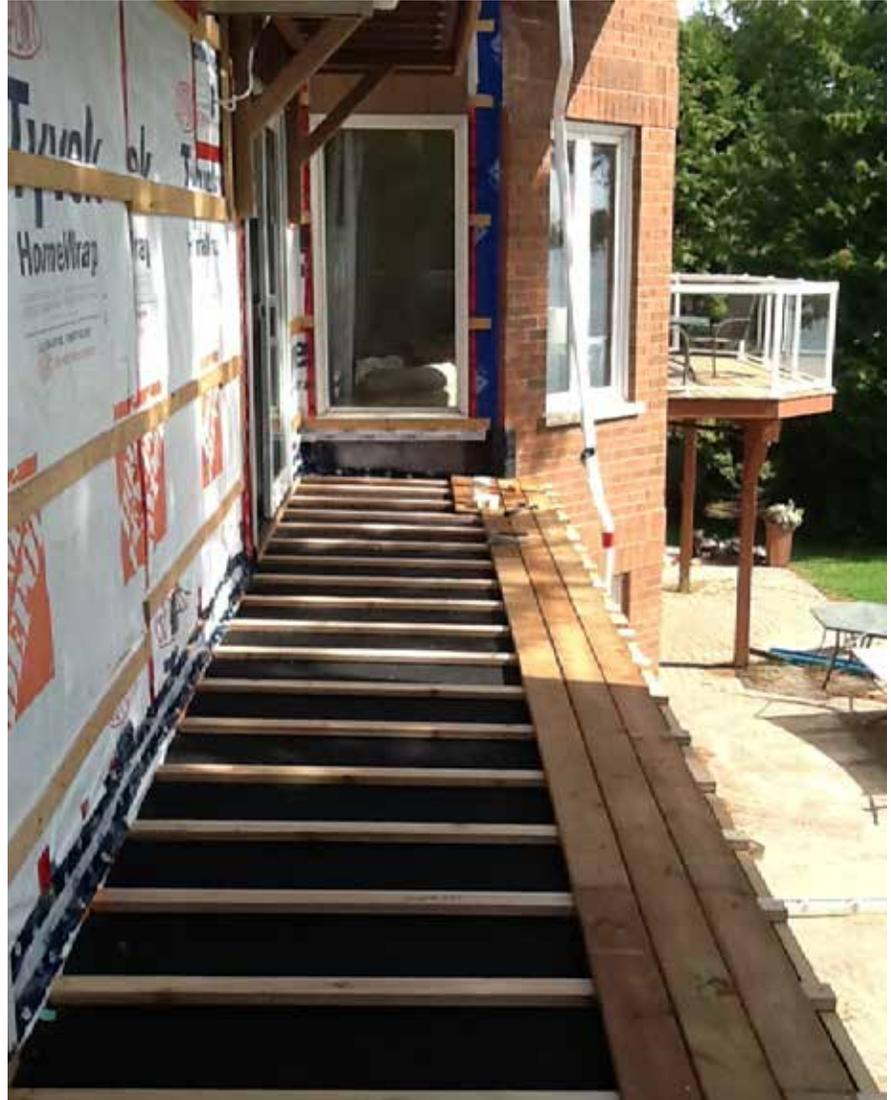
Covering the protected membrane roof with decking.
