Restoring an Historic Church to its Former Glory

By Mike Rekker, C.E.T., BSSO, Project Coordinator, Tacoma Engineers Inc., & Robert Mitchell, B.Arch., OAA, MRAIC, CAHP, Davenport Architectural Corporation

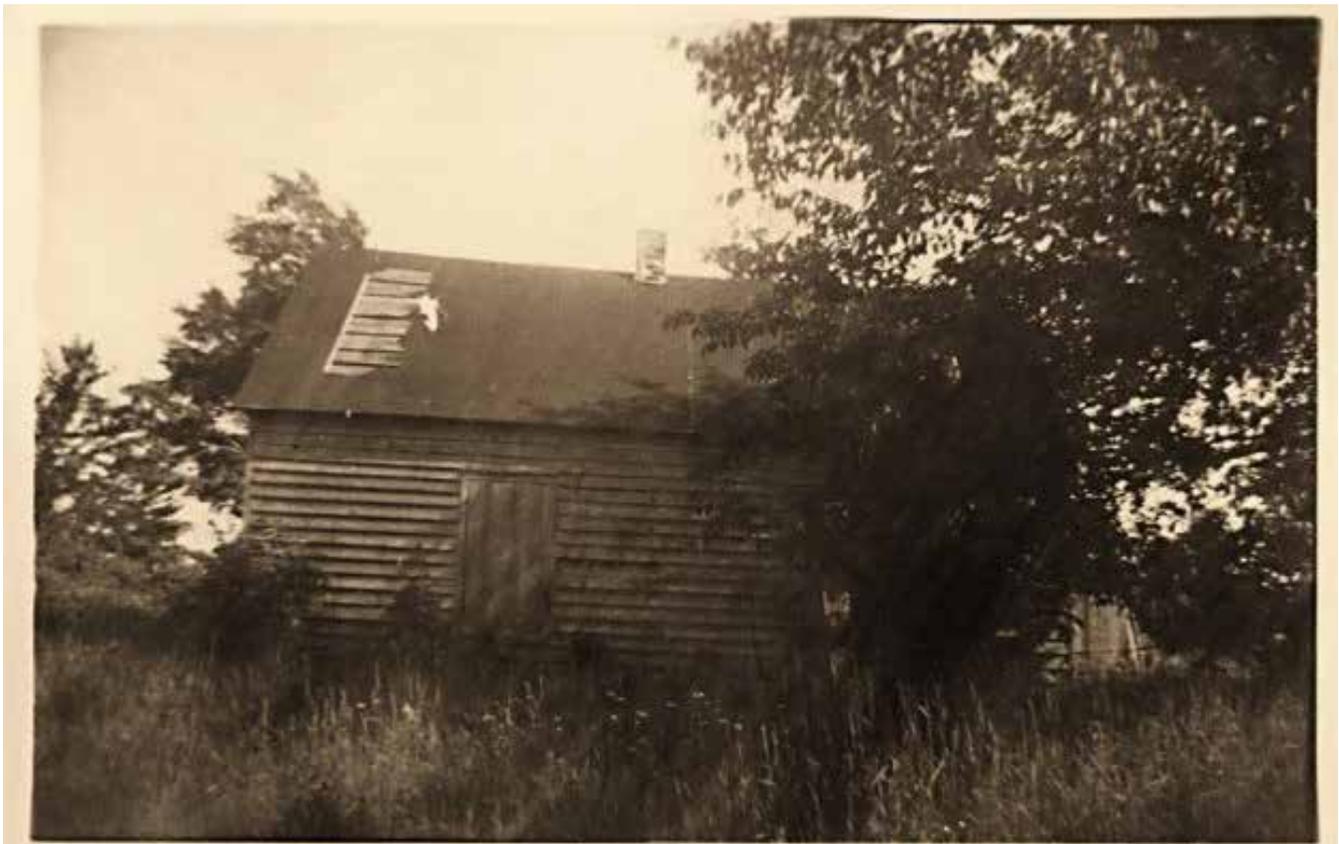
The Oro African Episcopal Methodist Church, 1941. Photo credit: The late Mrs. Jean (née Gilchrist) Blackstock.

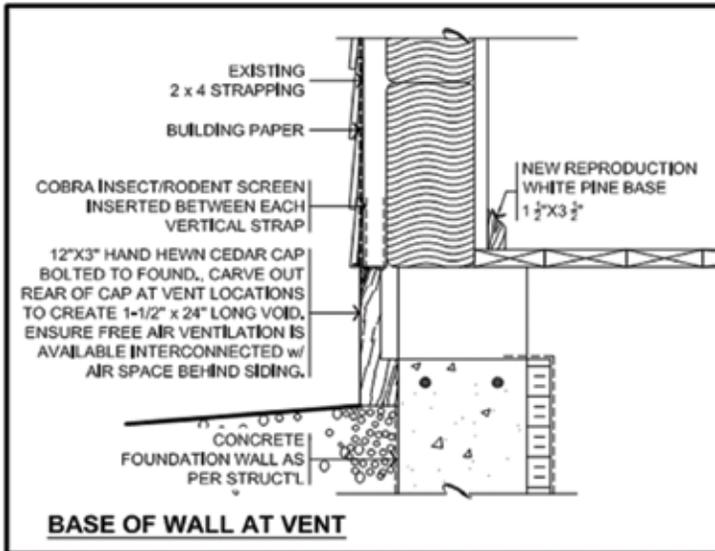
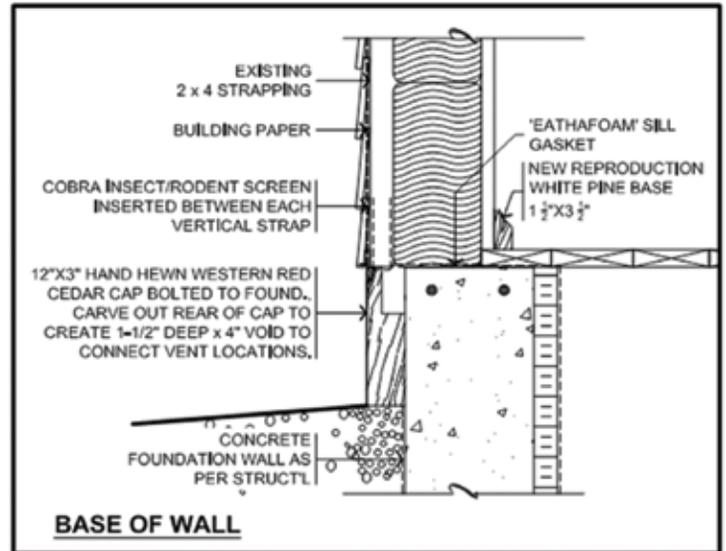
The exposed concrete wall was wrapped with a three-inch-thick (76-millimetre) by 12-inch-high (305-millimetre) cedar board as a cap wall. The cap was finished to replicate the exterior look of the original 12-inch-squared (305-millimetre-squared) cedar mud sill log, as can be seen in Figure 1 on the next page. This member was designed to be a "sacrificial" component expected to require occasional replacement from time to

Figure 1. A “superficial” sill log.

time due to its proximity to grade. The attachment was by stainless steel anchors and lags, which could be reused in the future. At the vent locations, the foundation cap included a one-and-a-half-inch deep (38-millimetre) by 24-inch-long (610-millimetre) notch on the backside to permit air flow into and out of the crawl space. The foundation

cap also included a one-and-a-half-inch deep (38-millimetre) by four-inch-wide (102-millimetre) continuous notch between foundation vent locations to provide cross-ventilation between foundation vents. The crawlspace venting is directly connected behind the foundation cap and functions through a stack effect with the full height cavity that extends to

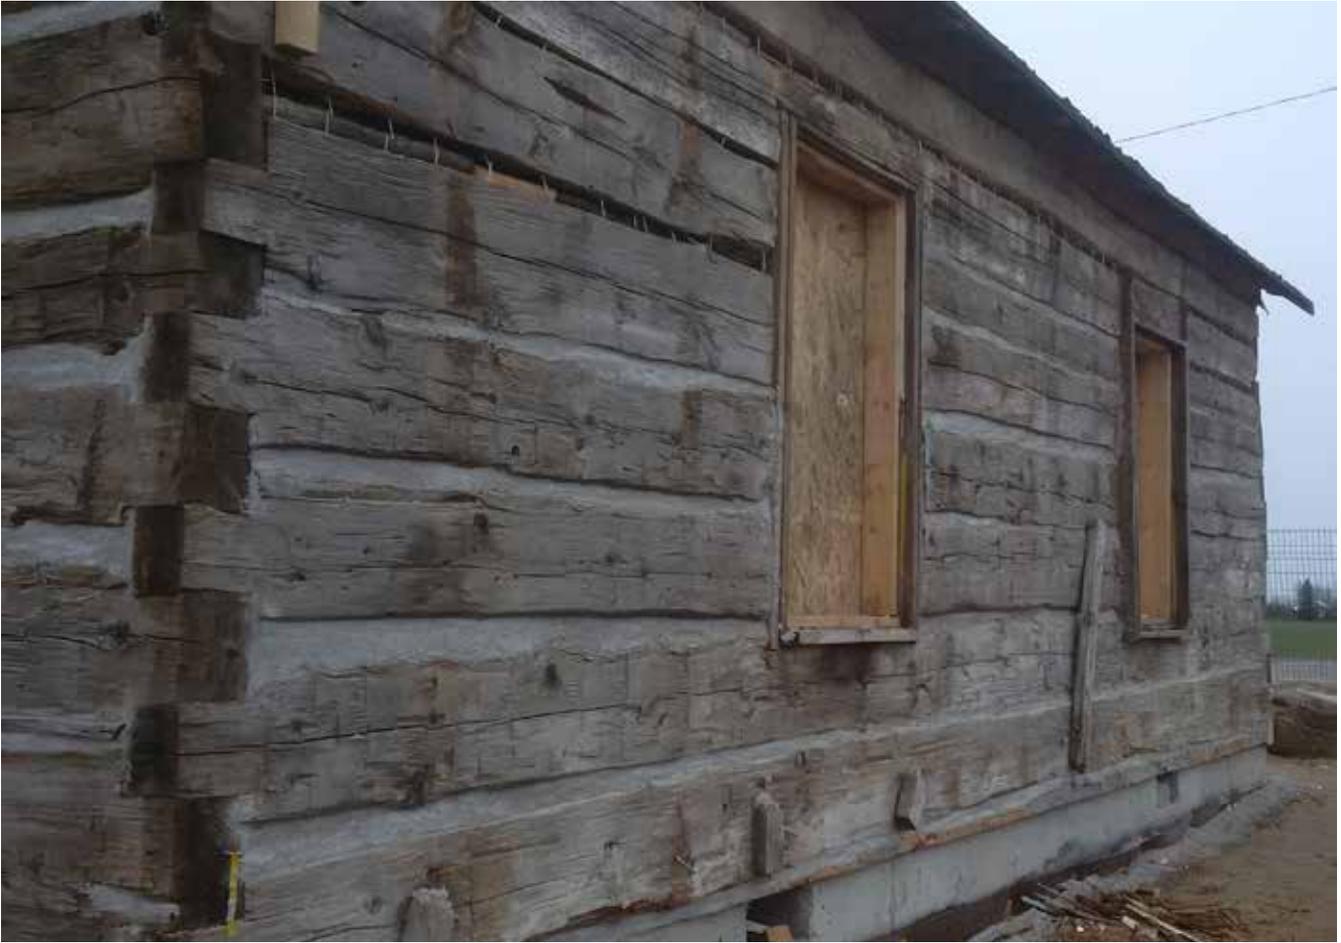
Chinking installation in 2016.

In addition to approximately 200 linear feet of exterior log repair and / or replacement, the existing chinking and daubing was replaced for the exterior log work. The new chinking was reused off the site from original material, including the reuse of existing chinking packing. Where required, cedar wedges and strips were also included. The new daubing was reinforced with concealed hot-dipped, zinc-coated nails, partially inserted in the upper side of the log (see photo on the next page). While the original daubing formula contained clay additive, it was decided in conjunction with representatives of Parks Canada to remove

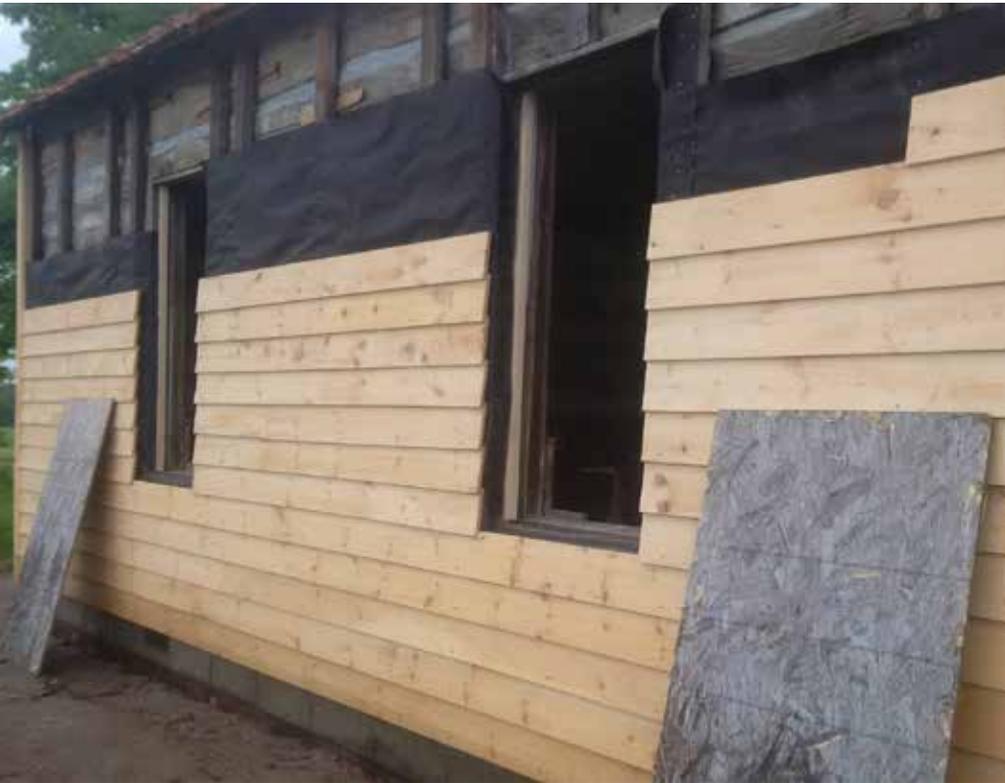
New cladding installation in 2016.

Where it was in good condition, existing rough sawn vertical strapping was left in place around the building's perimeter. Visible, modern nails were removed from the existing strapping and cut nails were left in place. Building paper (15# black felt paper) was applied to the exterior of the building on the vertical strapping to extend over the cedar cap and under the siding, so that moisture wicking is controlled. New seven-inch (178-millimetre) horizontal clapboard siding lapped one-inch (25-millimetre) board to board was installed as the finished cladding. The clapboard siding profile, thickness and lap was installed to match the existing clapboard that remained on the gable ends of the roof. Building paper was selected to act as a weather resistive barrier (WRB) at the exterior of the wall due to its ability to dry inward to the ventilated air space or outward in case of wetting. Compared to most modern housewrap, building paper will absorb and store water until drying conditions improve. Adding the breathable building paper would allow
