# Waterproofing Failures That Can Lead to Costly Repairs

By Daniel Aleksov, PEng., BSS is a principal at Leading Edge Building Engineers

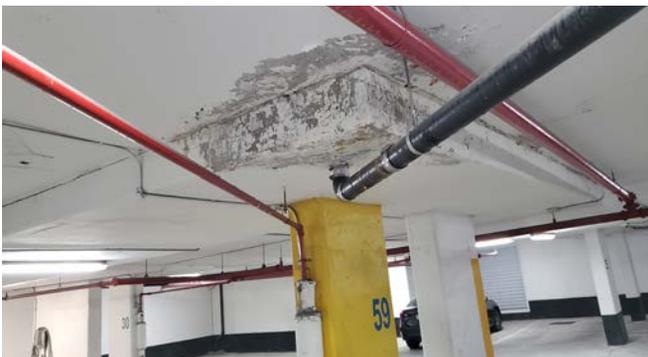
*A concrete ledge beam supporting an intermediate slab experiencing delaminated concrete due to premature failure of the preformed expansion joint installed less than 10 years ago.*

Without considering these types of questions, the designer can create vulnerabilities once the project is initiated. Locations and detailing of expansion joints and other types of penetrations, like drains, is critical since these areas are the most susceptible to failure of the waterproofing systems. During a recent garage condition assessment, we observed a concrete ledge beam supporting the intermediate slab was experiencing delaminated concrete due to premature failure of the preformed expansion joint installed less than 10 years ago (see photo below).

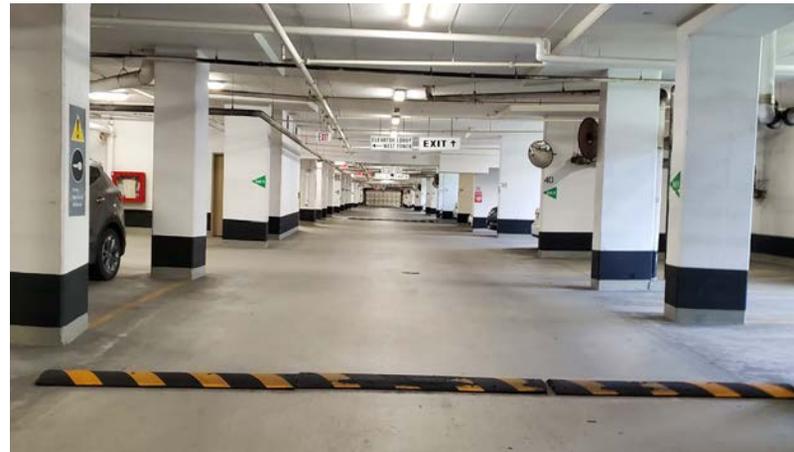
Localized repairs and replacement of worn and debonded membranes should be addressed as part of a maintenance plan to avoid leaving the concrete unprotected and exposed to water and de-icing salt, which can lead to corrosion of the embedded reinforcing steel.

The minimum maintenance standards involve annual reviews by building staff, ensuring the slabs’ drains are free of debris and vehicle traffic waterproofing systems are cleaned on a regular basis. Part of this review should include accessing the hydro vault to ensure there is no evidence of water penetration, which could cause a potential fire or explosion. Localized repairs and replacement of worn and debonded membranes should be addressed as part of a maintenance plan to avoid leaving the concrete unprotected and exposed to water and de-icing salt, which can lead to corrosion of the embedded reinforcing steel (see photo above).

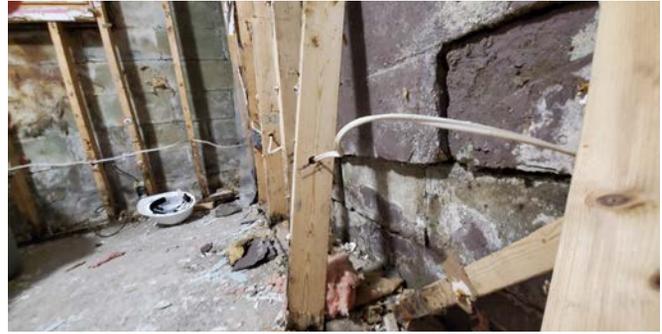
During renovations to a 98-year-old detached house, a contractor discovered major sub-floor damage caused by water penetration from the exterior concrete block foundation wall. The wall was protruding 50 to 75mm out of plane, likely from frost.

Recently, a 98-year-old detached house was undergoing basement renovations, and the contractor discovered major sub-floor damage caused by water penetration from the exterior concrete block foundation wall. The wall was observed to be protruding 50 to 75mm out of plane, likely from frost (see photo on page 24). This is a very serious condition, with potential for the foundation wall to catastrophically collapse. Emergency shoring has been installed, and the wall

is scheduled to be replaced with new waterproofing and drainage installed along the entire length of the wall elevation.
