# Reconstruction of an Underground Parking Garage Concrete Slab on Grade

By Emma Ruixian Qian, Architectural Technologist, WZMH Architects

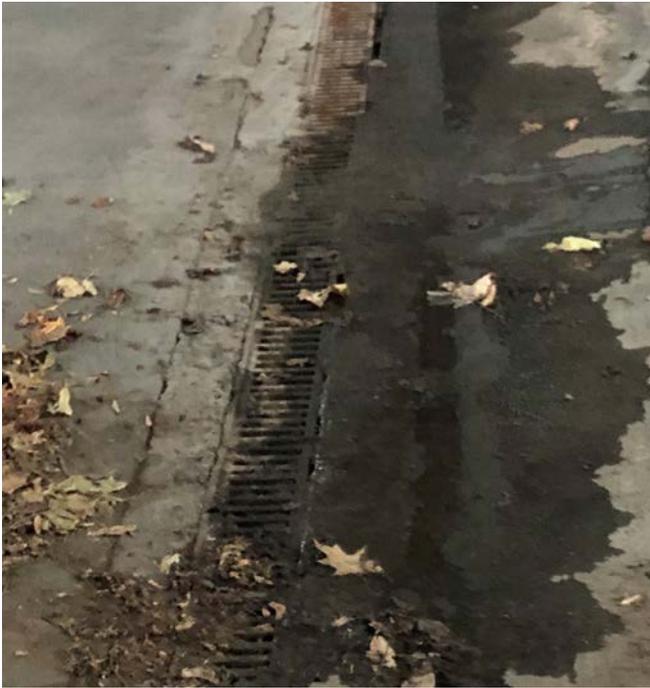
*The previous metal drain here is corroded, which left standing water on the surface.*

After a site inspection, it became clear the existing clay weeping tile drainage system was unsuitable for the existing building system. We selected a polyvinyl chloride (PVC) tile to replace the existing clay weeping tile, and kept as many of the existing weeping holes as possible within the concrete foundation wall to maintain the structure's strength and reduce reconstruction labour. We used high-performance, galvanized steel in the trench system to allow for easy draining, should the system become clogged, and we installed drains throughout the slab to allow water to drain more easily.

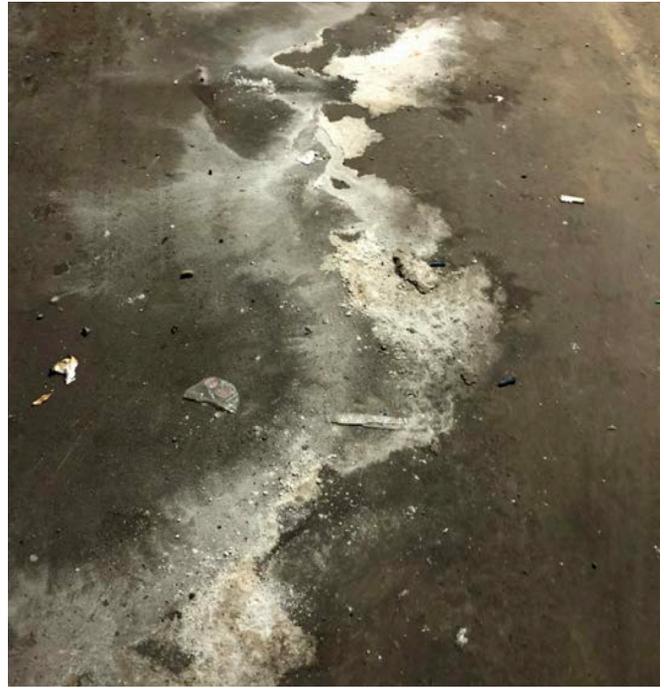
Water moisture can cause a variety of problems, like efflorescence, the white, crystalline substance that can occur on the surfaces of unsealed concrete. These deposits often contain compounds such as calcium, sodium, and potassium hydroxides or carbonates, bicarbonates, chlorides, and sulfates of calcium and magnesium. These substances typically originate as soluble compounds within the concrete that are transported and deposited on the surface

by upward moisture migration and evaporation. Water is the solvent and vehicle for transporting the soluble salts to the surface. Efflorescence can form a thick layer on the surface that can completely hide the concrete's colour, create unsightly white patches, and degrade the slab strength.

*Another sign of water damage and deterioration is efflorescence, an often-white powdery substance that appears on the slab's surface.*
